# Transportation Project Report

## Draft Project Scoping Report/Final Design Report

Main Street over Little Lake Erie Outlet Culvert Replacement  
Project Identification Number (PIN): 9754.85  
Bridge Identification Number (BIN): NA  
Town of Tusten  
Sullivan County

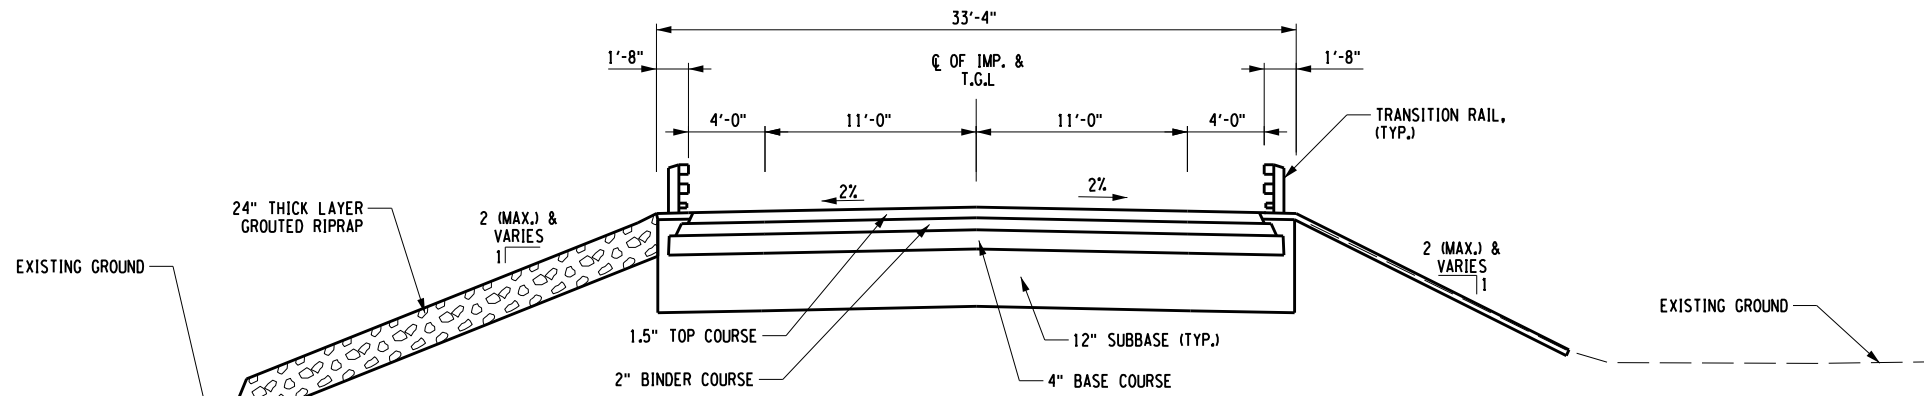
TYPICAL FINAL APPROACH SECTION

NOT TO SCALE  
STA 10+57.37 TO STA 10+88.23  
STA 11+27.54 TO STA 11+48.86

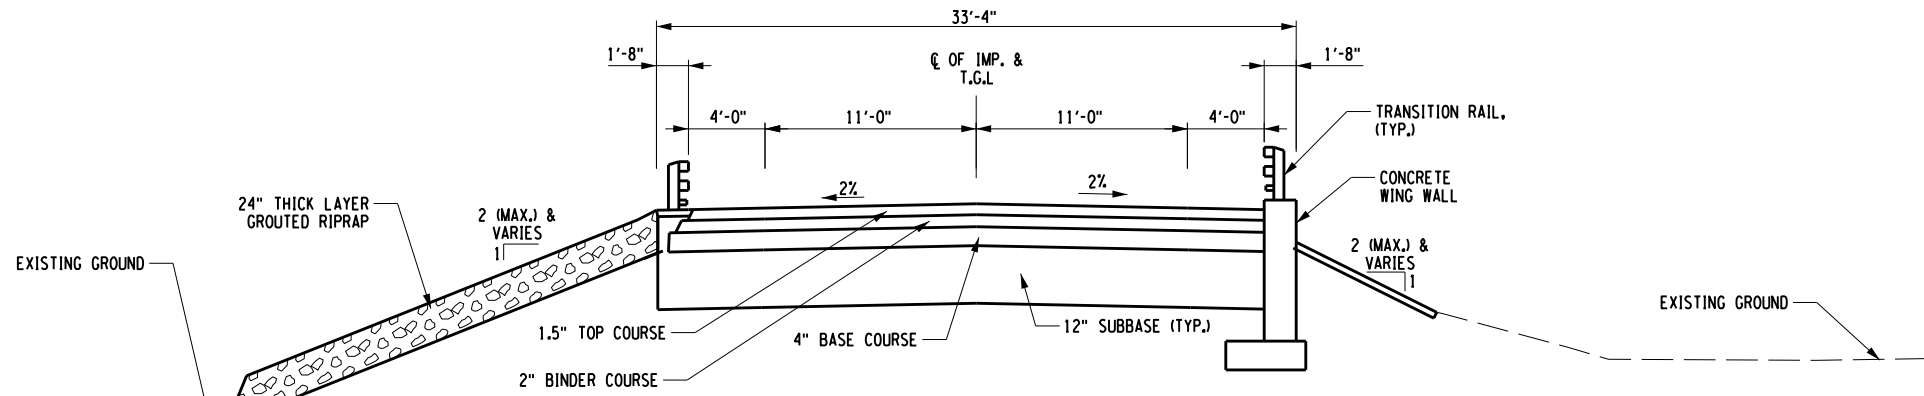
TYPICAL FINAL APPROACH SECTION

NOT TO SCALE  
STA 10+88.23 TO STA 10+98.03  
STA 11+17.54 TO STA 11+27.54

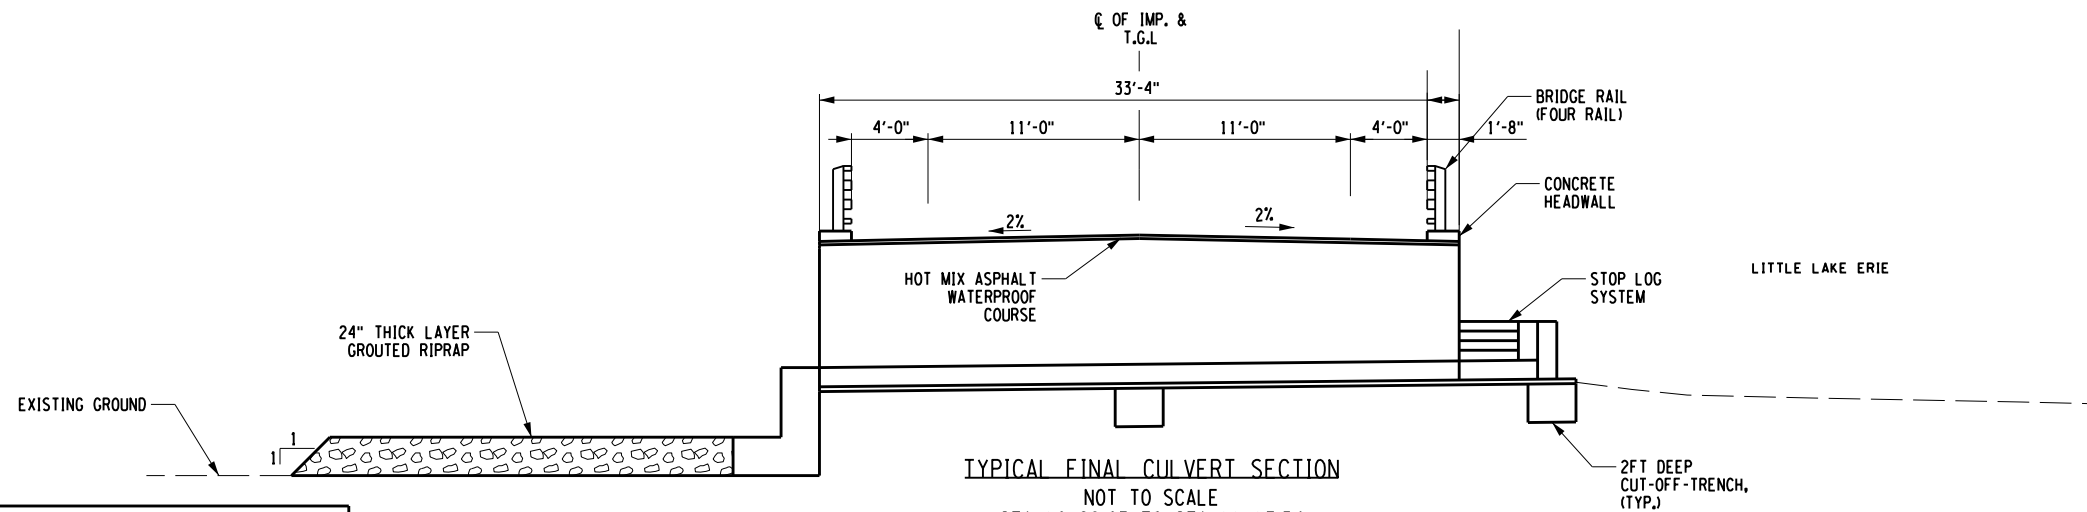
TYPICAL FINAL CULVERT SECTION

NOT TO SCALE  
STA 10+98.03 TO STA 11+17.54

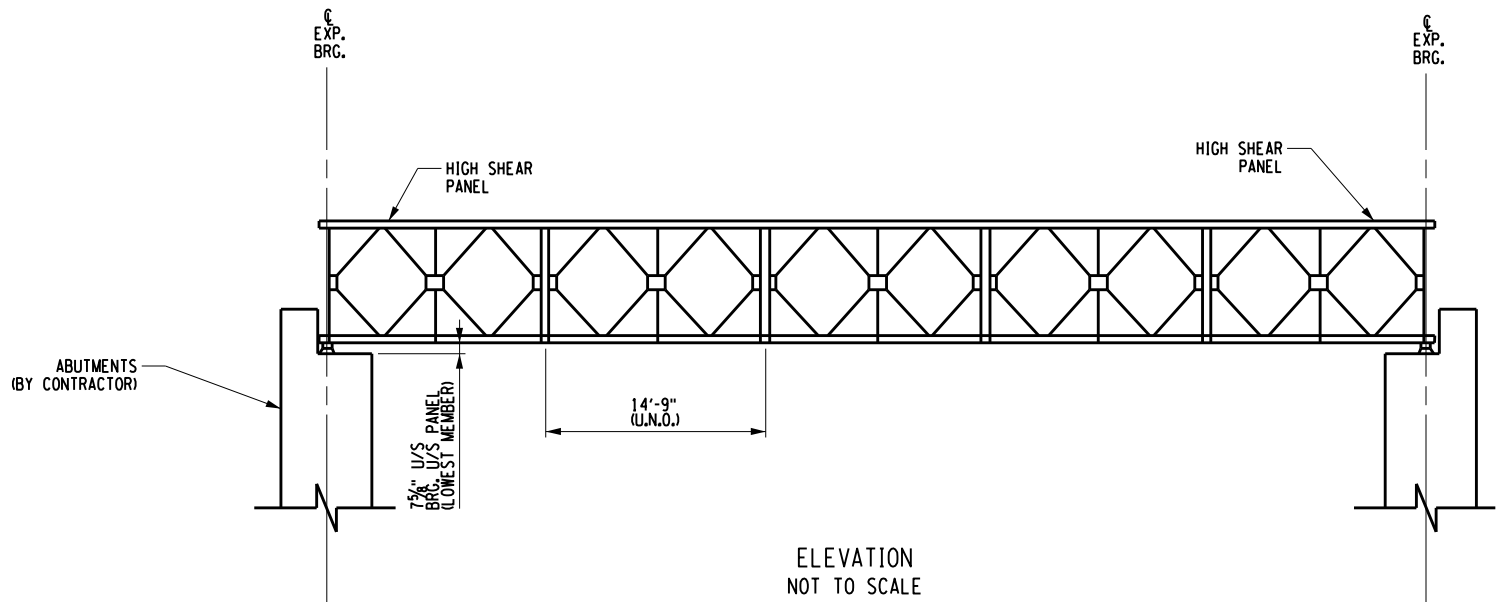
- NOTE:
- SECTION AND ELEVATION SHOWN IS FOR ILLUSTRATION ONLY. CONTRACTOR IS RESPONSIBLE FOR PROVIDING A TEMPORARY STRUCTURE AND APPROACH IN ACCORDANCE WITH ITEM 619.0601 AND THE PLANS.
  - TEMPORARY STRUCTURE SHALL HAVE A DECK WITH A FRICTION AGGREGATE OF 2 OR EQUAL.
  - REQUIREMENTS:
    - MINIMUM TEMPORARY STRUCTURE CLEAR WIDTH BETWEEN CURBS ON THE THE BRIDGE = 24 FT. (2 - 6 FT. SHOULDERS AND 1 - 24 FT. LANE)
    - MINIMUM TEMPORARY APPROACH ROADWAY WIDTH = 24 FT.
    - ESTIMATED TEMPORARY BRIDGE SPAN = 73 FT.
    - MINIMUM APPROACH ROADWAY ASPHALT PAVEMENT THICKNESS = 6 IN.
    - MINIMUM APPROACH ROADWAY SUBBASE THICKNESS = 10 IN.
    - ALL TURNING RADIUS SHALL MEET THE MINIMUM TURNING RADIUS FOR A WB-62.

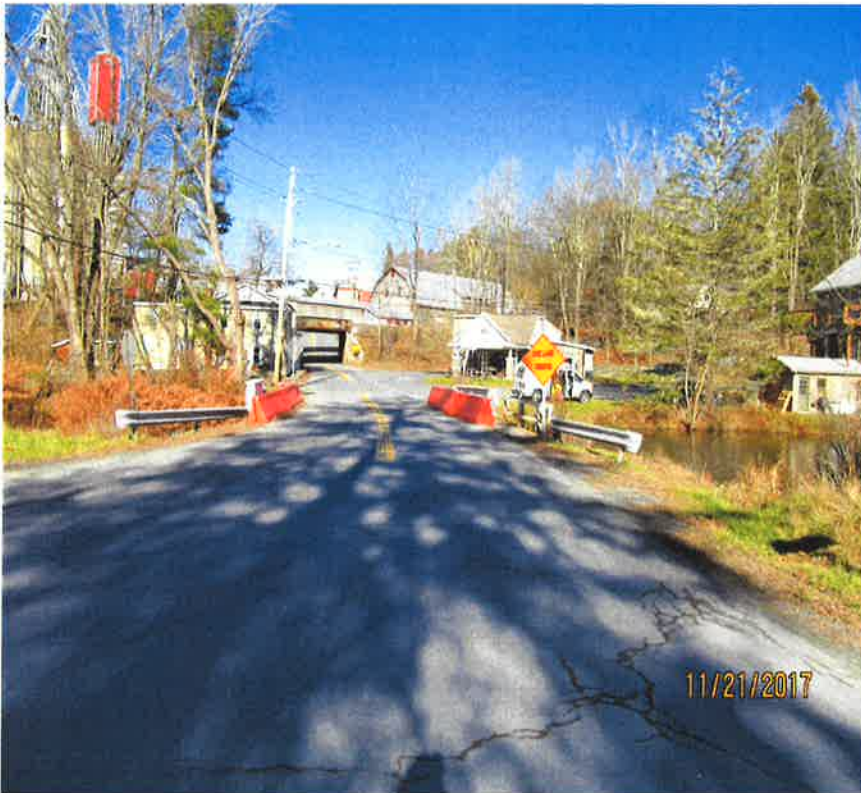
**Photo 1**

**Begin Approach to Culvert.  
Note barricades placed  
over the left and right  
sides of the culvert to  
reduce roadway width and  
"One-Lane Bridge" posting.**

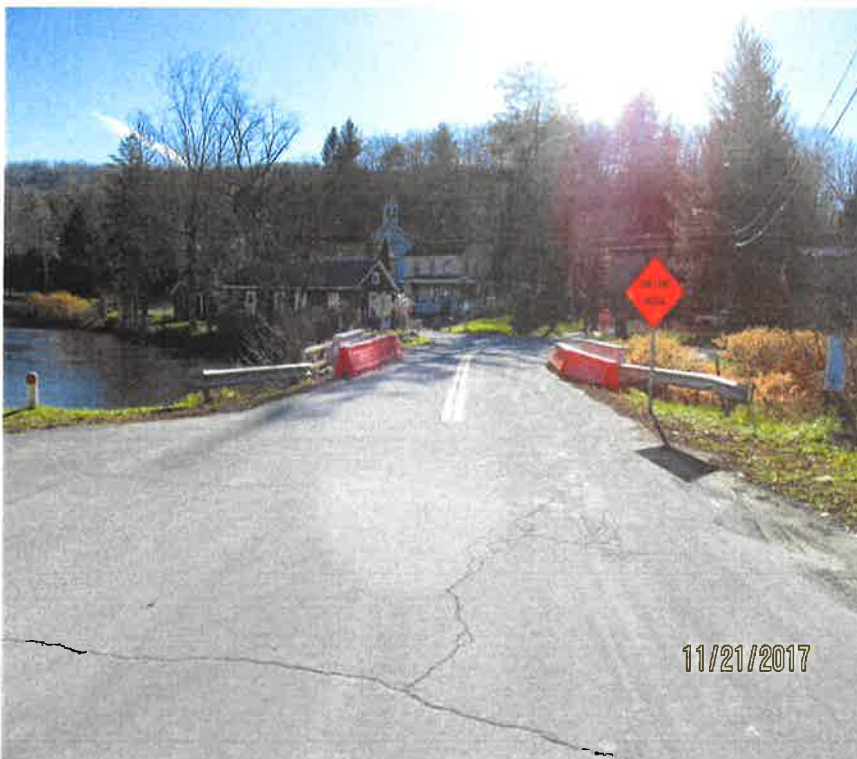
**Photo 2**

**End Approach to Culvert.  
Note barricades placed  
over the left and right  
sides of the culvert to  
reduce roadway width and  
"One-Lane Bridge" posting.**

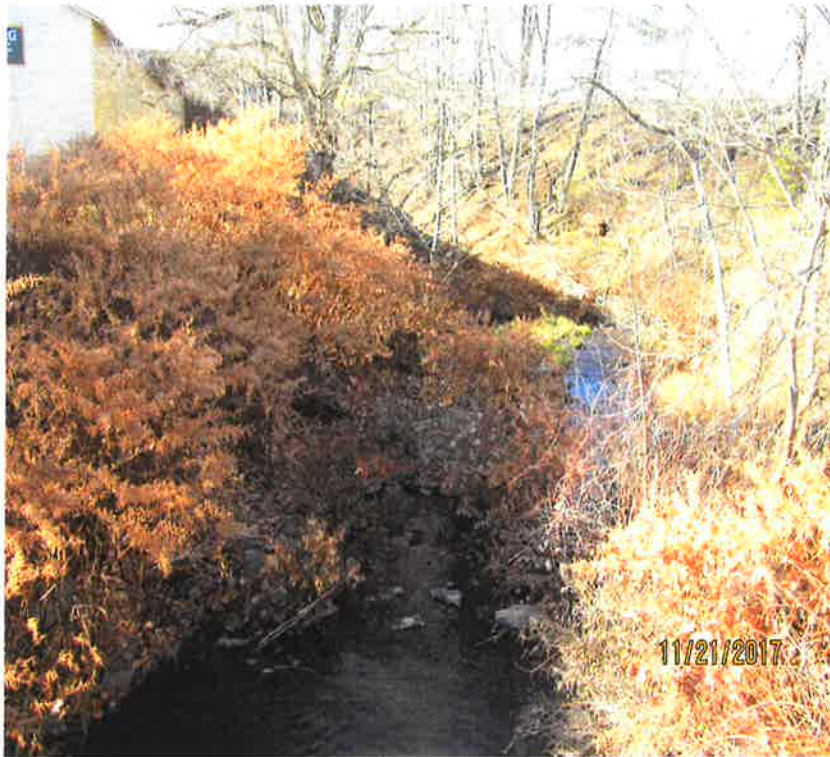
**Photo 3**

**Waterway channel on left  
(downstream) side of  
culvert.**

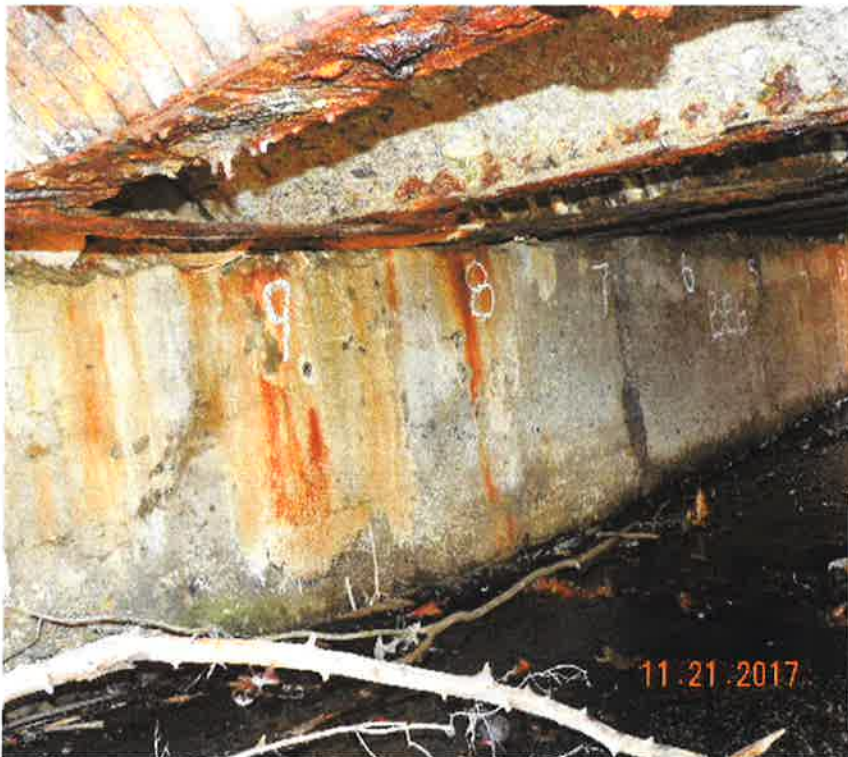
Photo 6

Begin Abutment from end right.

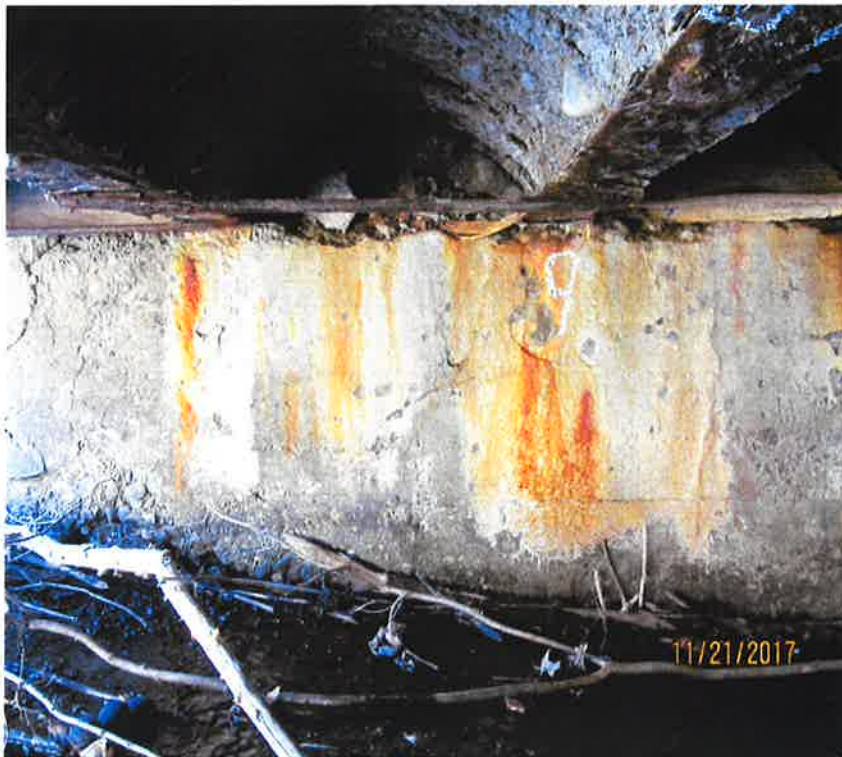
Photo 9

Begin Abutment Stem  
along middle of culvert.

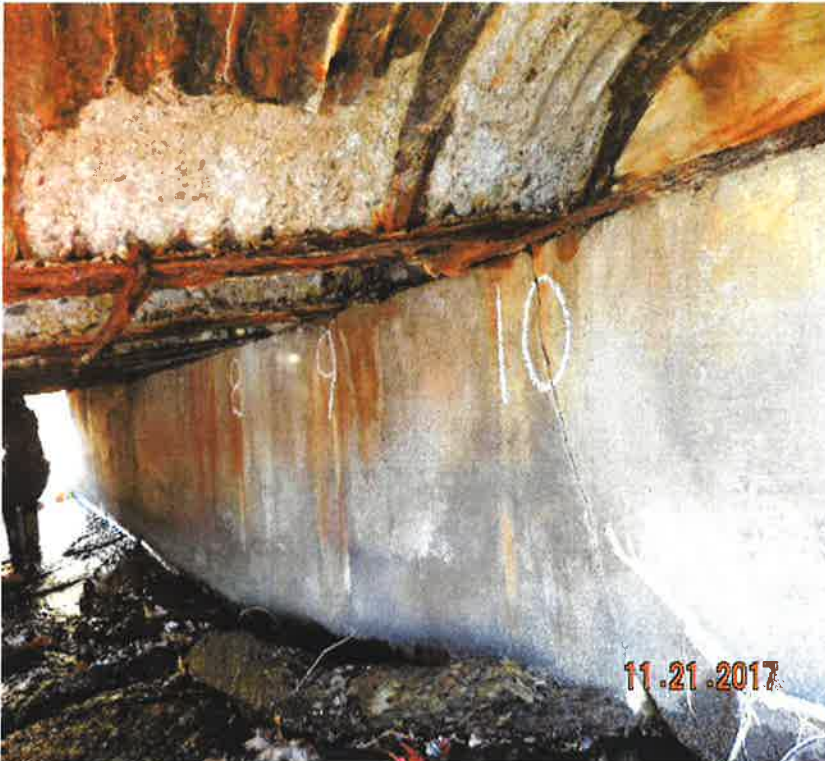
Photo 13

End Abutment along the  
right side of the culvert.

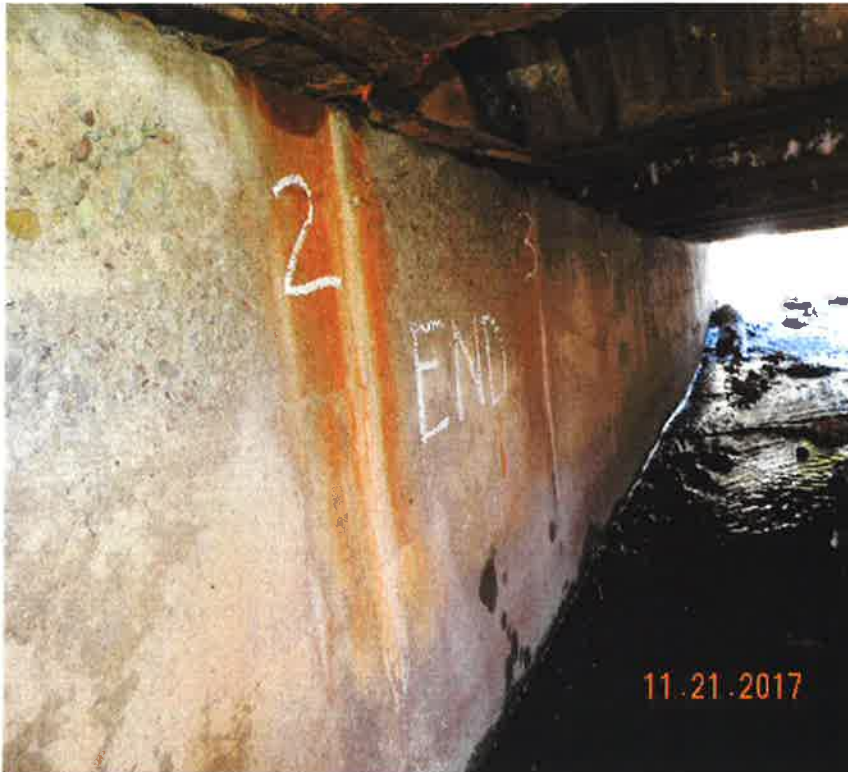
Photo 15

End Abutment Stem on the  
left side.

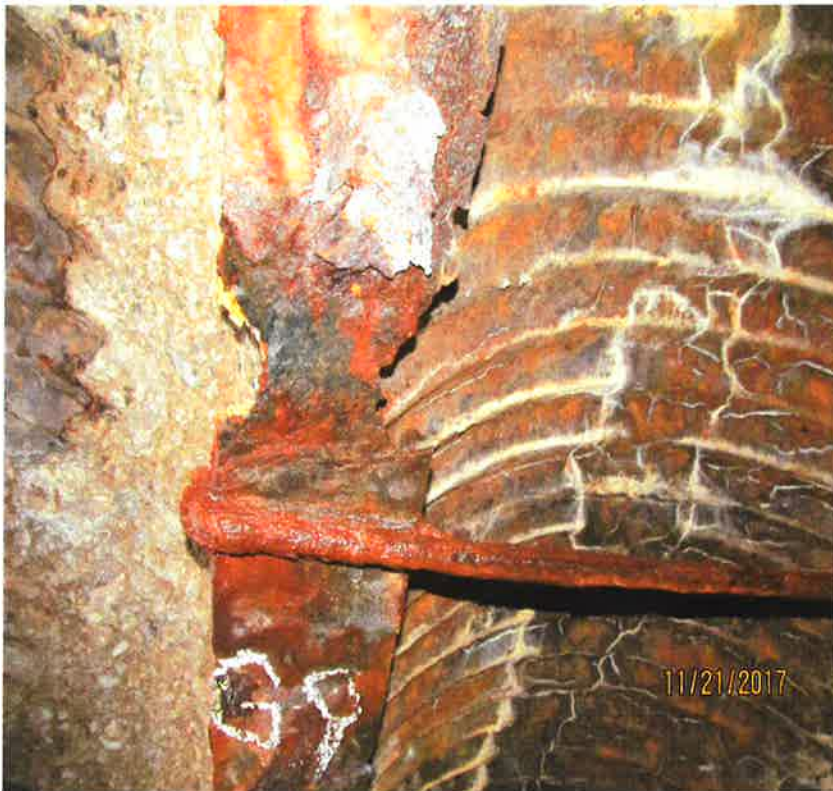
Photo 19

Bottom flange of Girder G-9 at mid span of culvert.

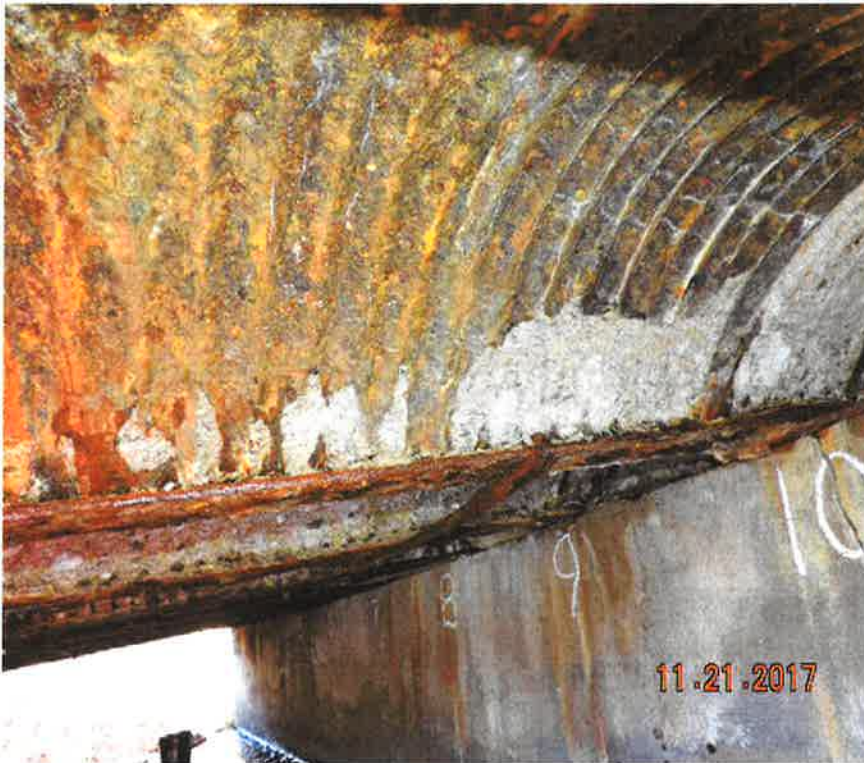
Photo 21

Typical jack arch deck condition along bottom flanges of girders in culvert.

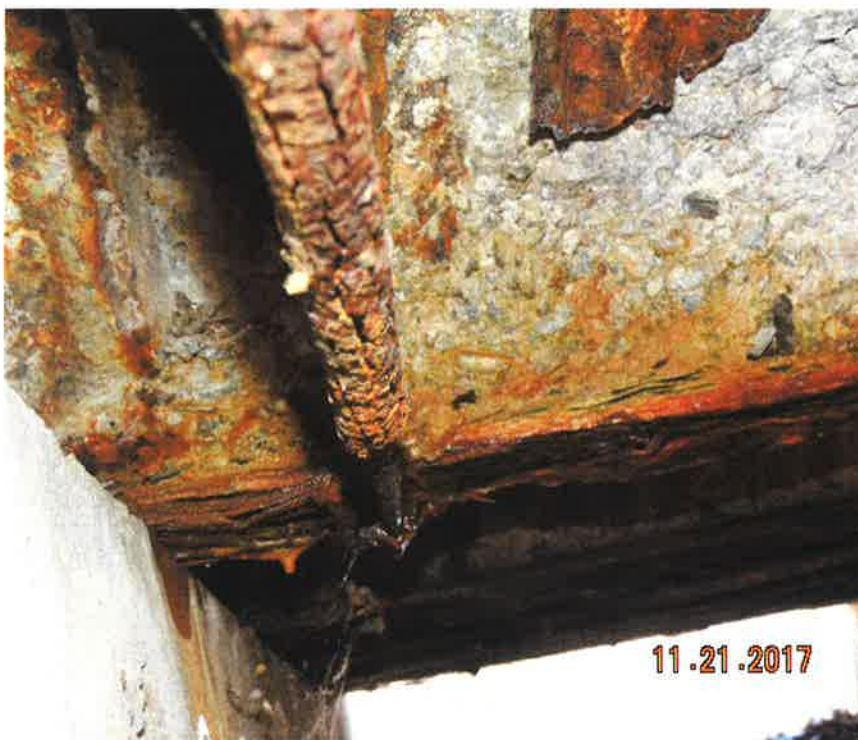
Photo 22

Jack arch at end of culvert span. Typical jack arch concrete condition.

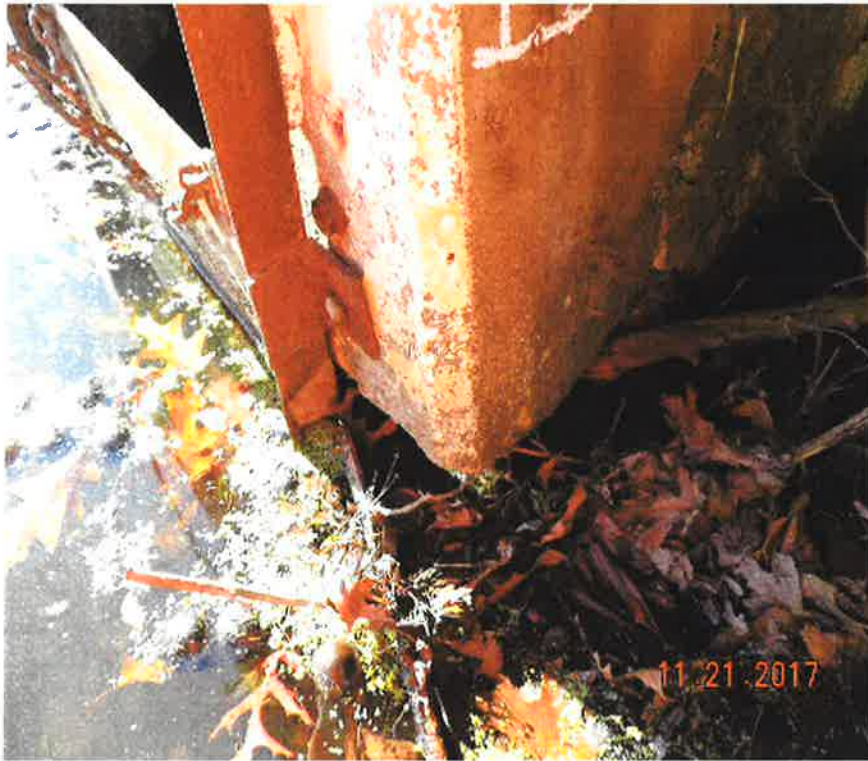
**Photo 23**

**Right (upstream) side of  
culvert adjacent to sluice gate.**

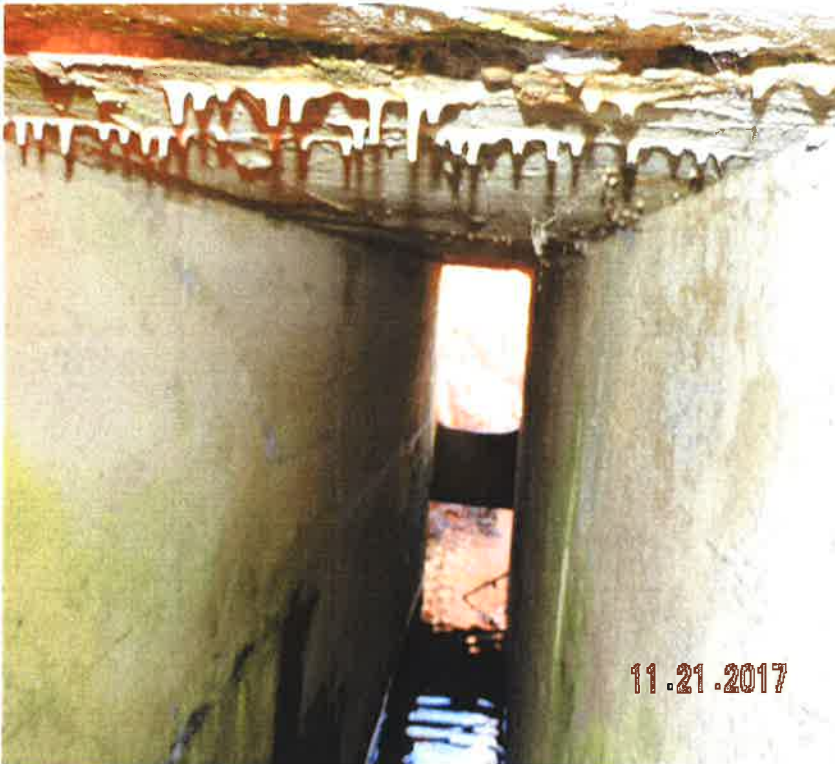
Photo 25

Sluiceway on begin (south)  
side of culvert.

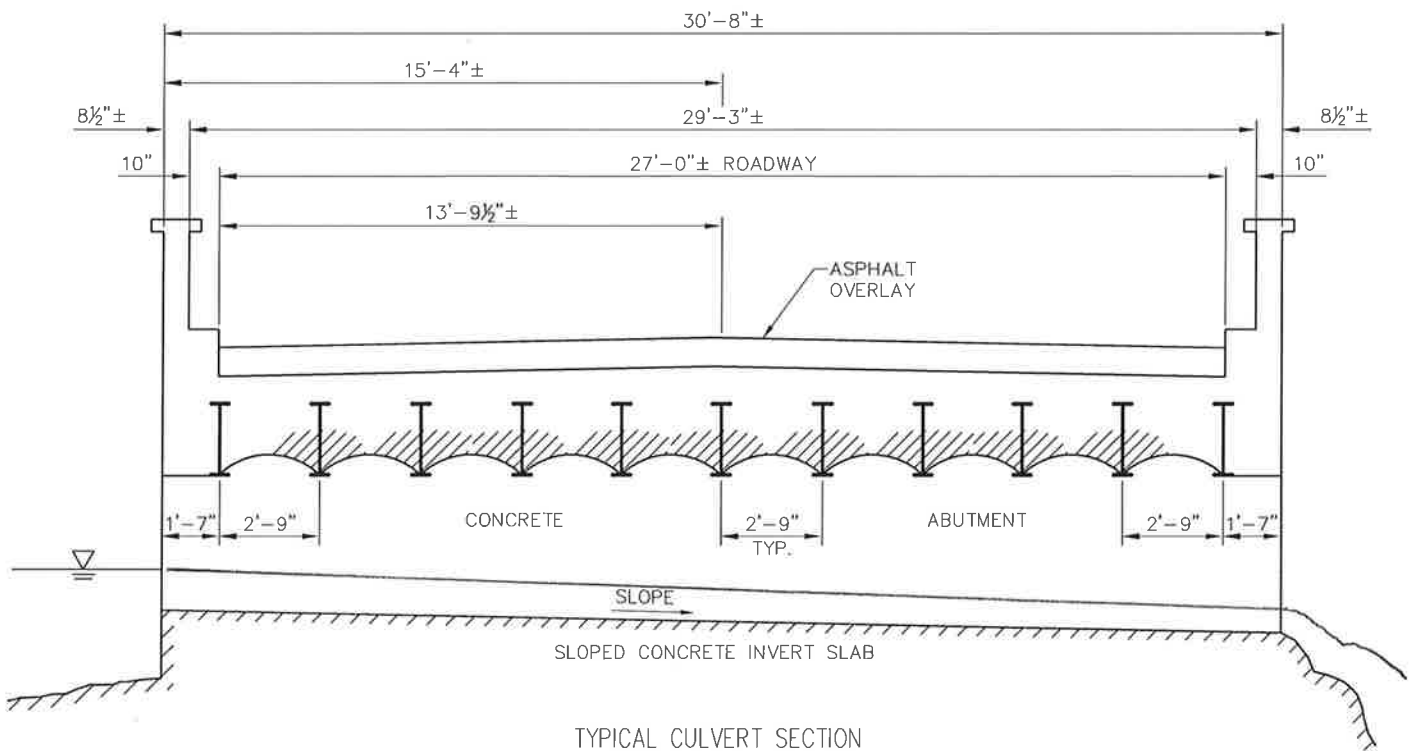
TYPICAL CULVERT SECTION  
AT BEGIN ABUTMENT  
(LOOKING SOUTH)

ABUTMENT HEIGHT  
VARIES - MIN. 3'-8"

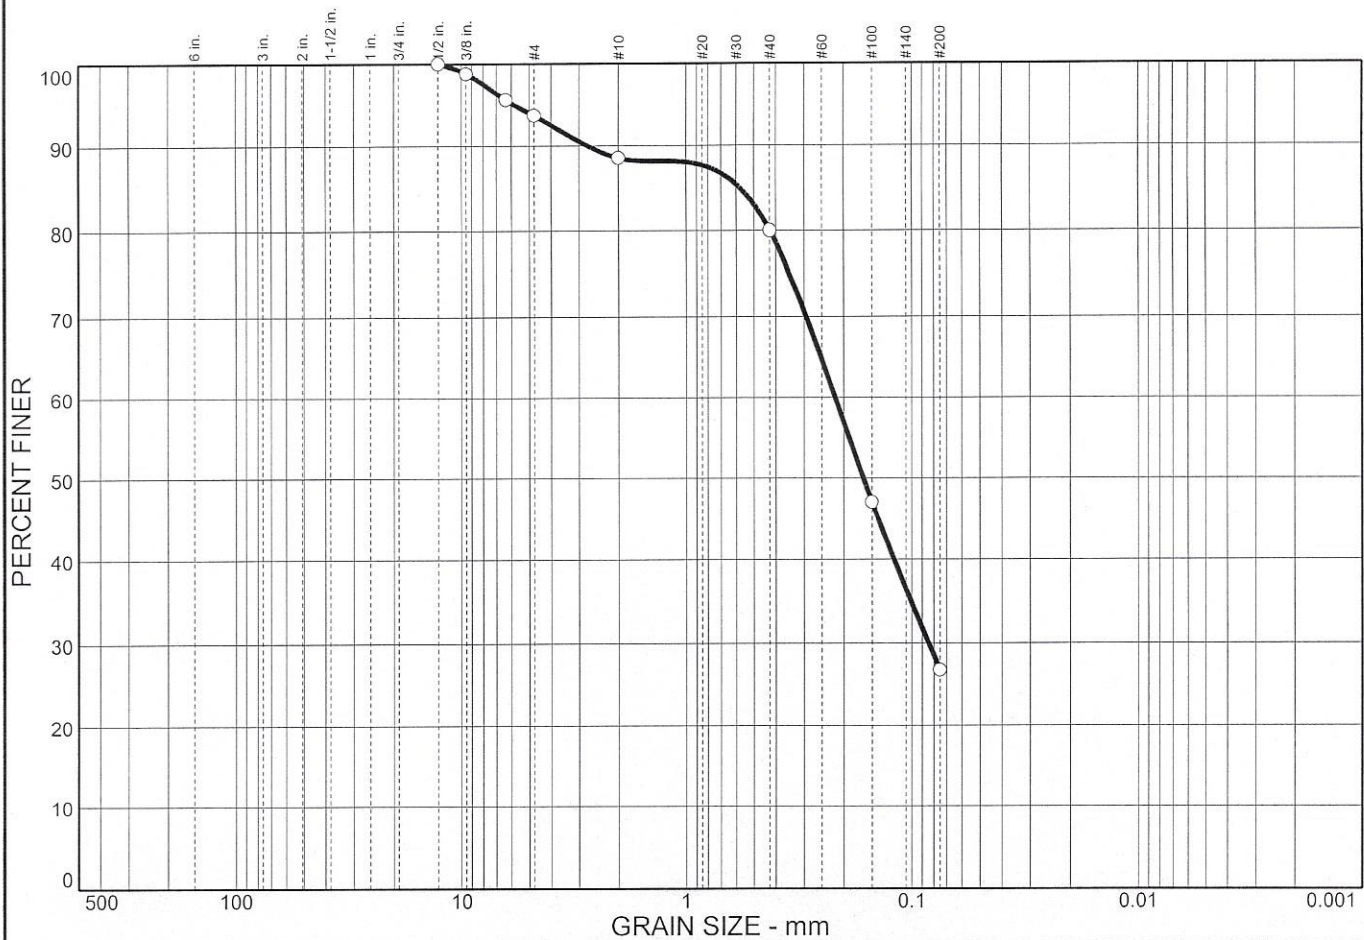
% COBBLES	% GRAVEL	% SAND	% SILT	% CLAY
0.0	6.3	66.9	26.8

SIEVE SIZE	PERCENT FINER	SPEC.* PERCENT	PASS? (X=NO)
1/2 in.	100.0		
3/8 in.	98.8		
1/4 in.	95.6		
#4	93.7		
#10	88.5		
#40	80.0		
#100	47.0		
#200	26.8

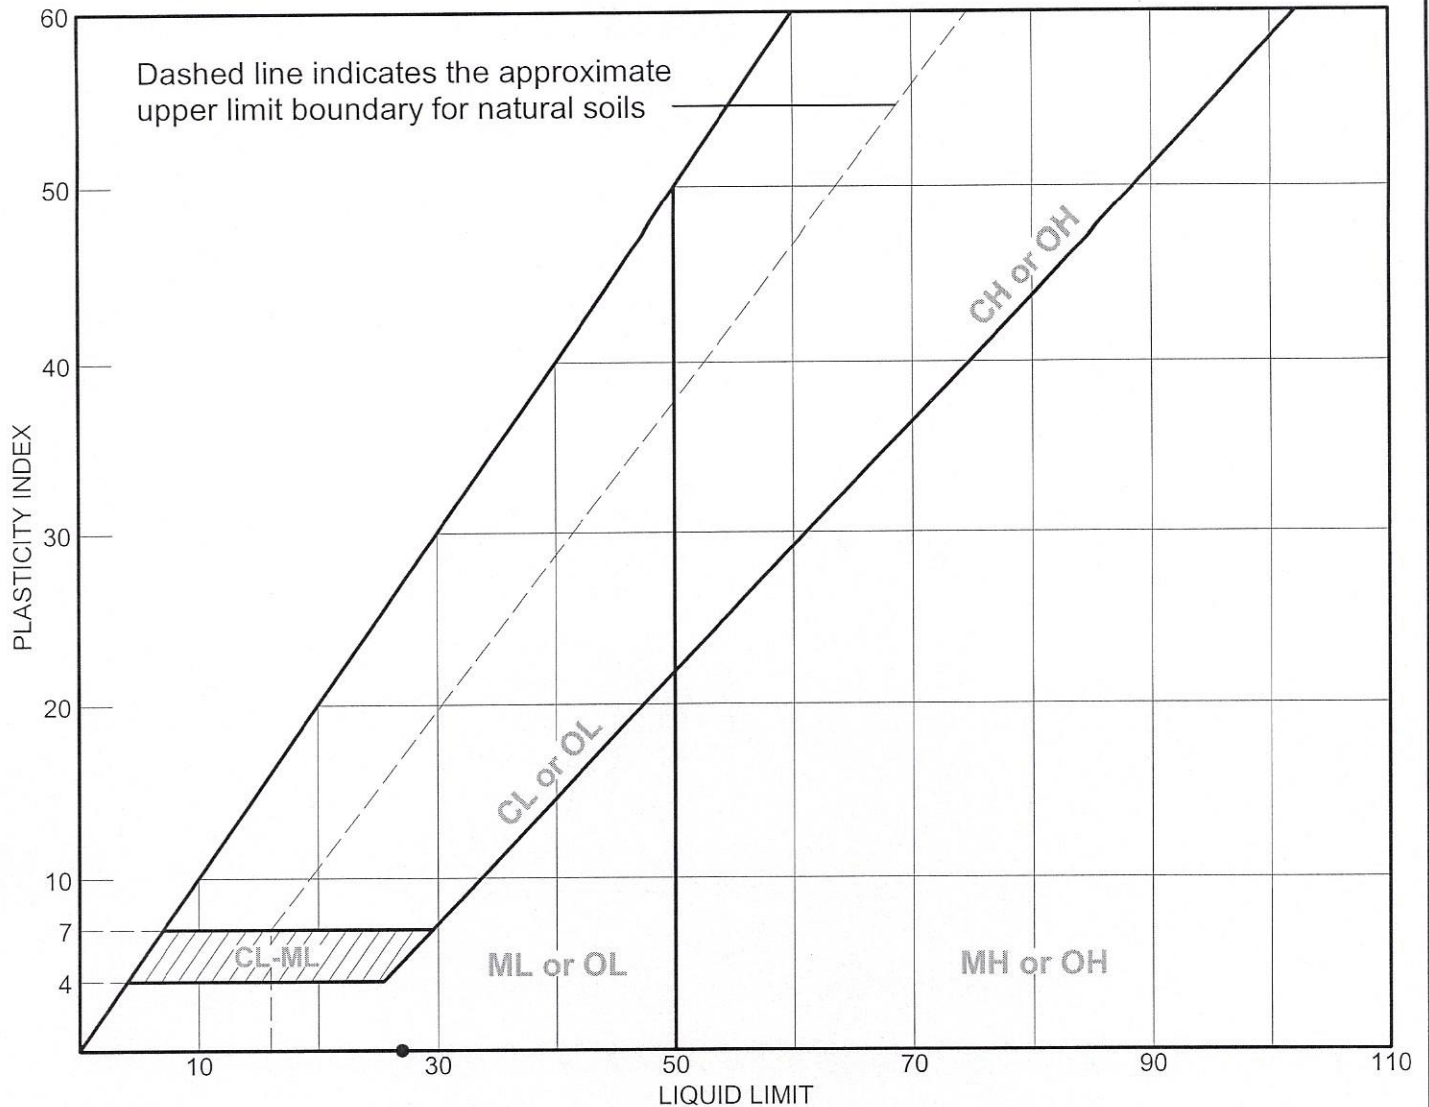
LIQUID AND PLASTIC LIMITS TEST REPORT

SOIL DATA								
SYMBOL	SOURCE	SAMPLE NO.	DEPTH (ft.)	NATURAL WATER CONTENT (%)	PLASTIC LIMIT (%)	LIQUID LIMIT (%)	PLASTICITY INDEX (%)	USCS
•	B-1	9-009	20-22'	27.2	NP	27	NP

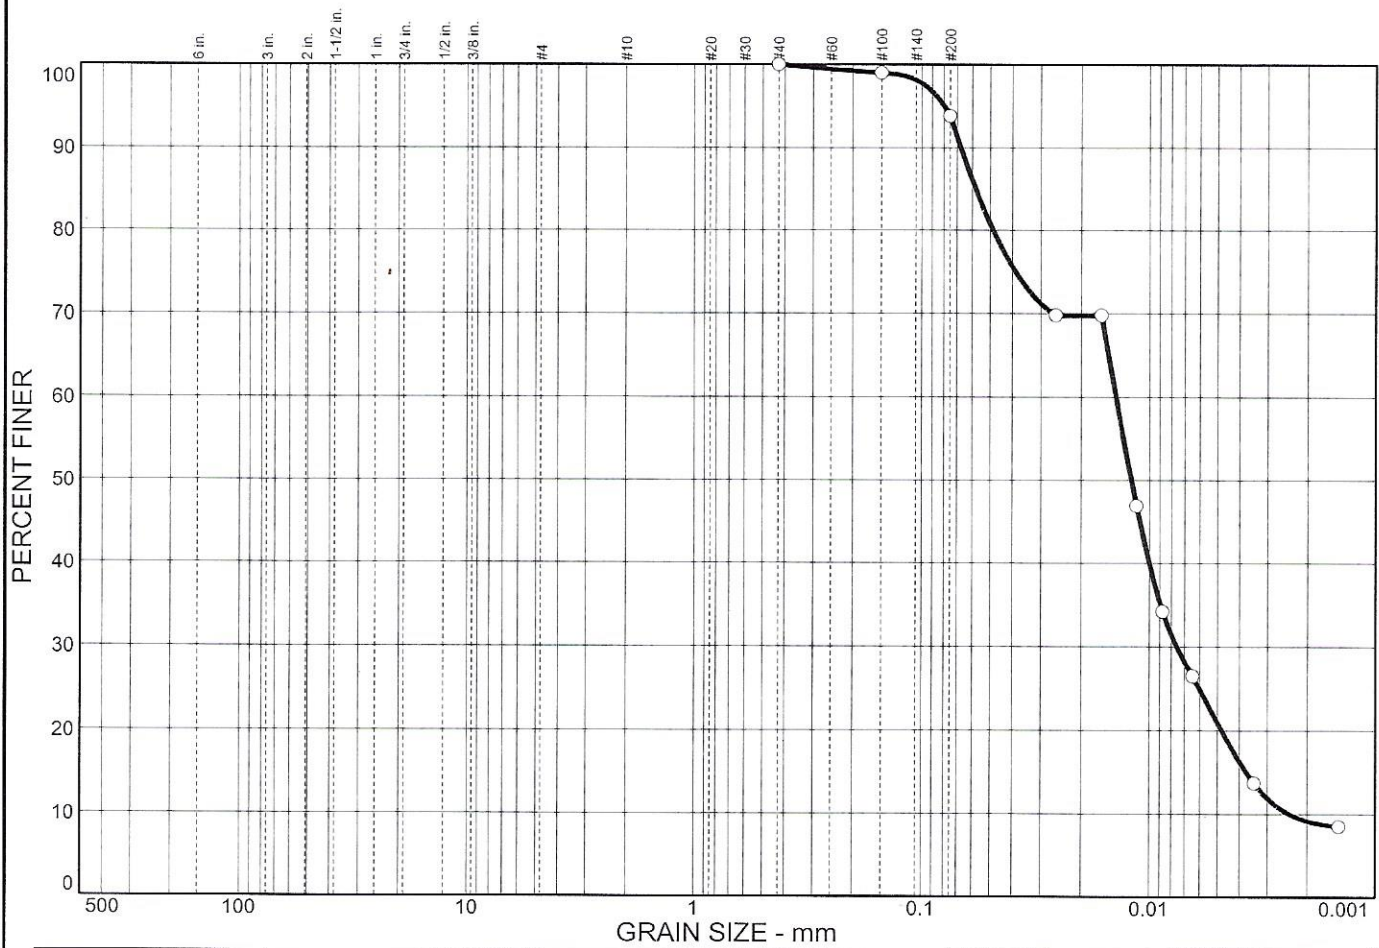
% COBBLES	% GRAVEL	% SAND	% SILT	% CLAY
0.0	0.0	6.2	72.9	20.9

SIEVE SIZE	PERCENT FINER	SPEC.* PERCENT	PASS? (X=NO)
#40	100.0		
#100	99.0		
#200	93.8

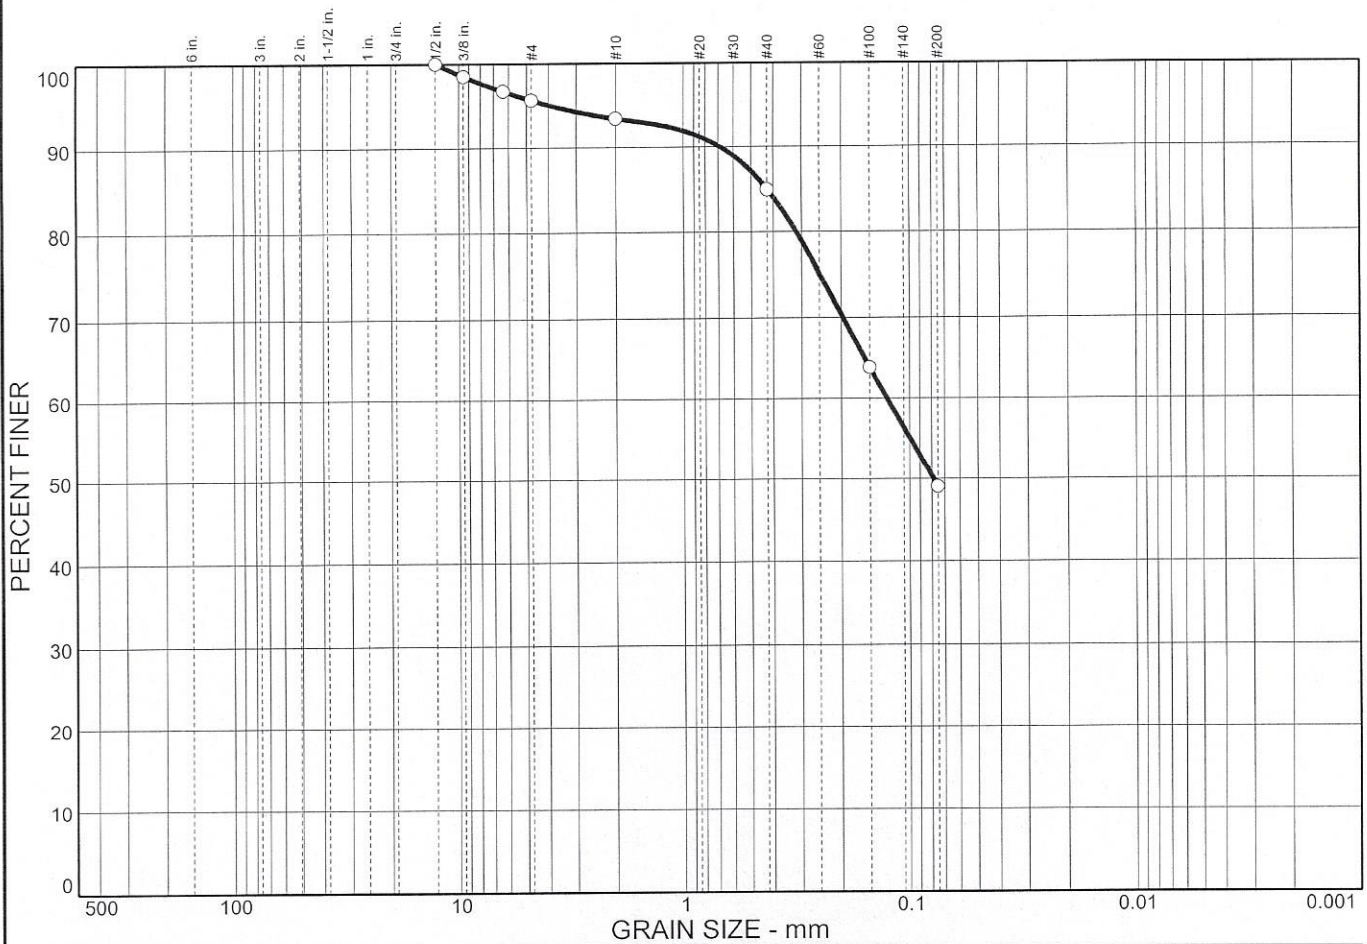
% COBBLES	% GRAVEL	% SAND	% SILT	% CLAY
0.0	4.4	46.6	49.0

SIEVE SIZE	PERCENT FINER	SPEC.* PERCENT	PASS? (X=NO)
1/2 in.	100.0		
3/8 in.	98.5		
1/4 in.	96.7		
#4	95.6		
#10	93.4		
#40	84.9		
#100	63.9		
#200	49.0

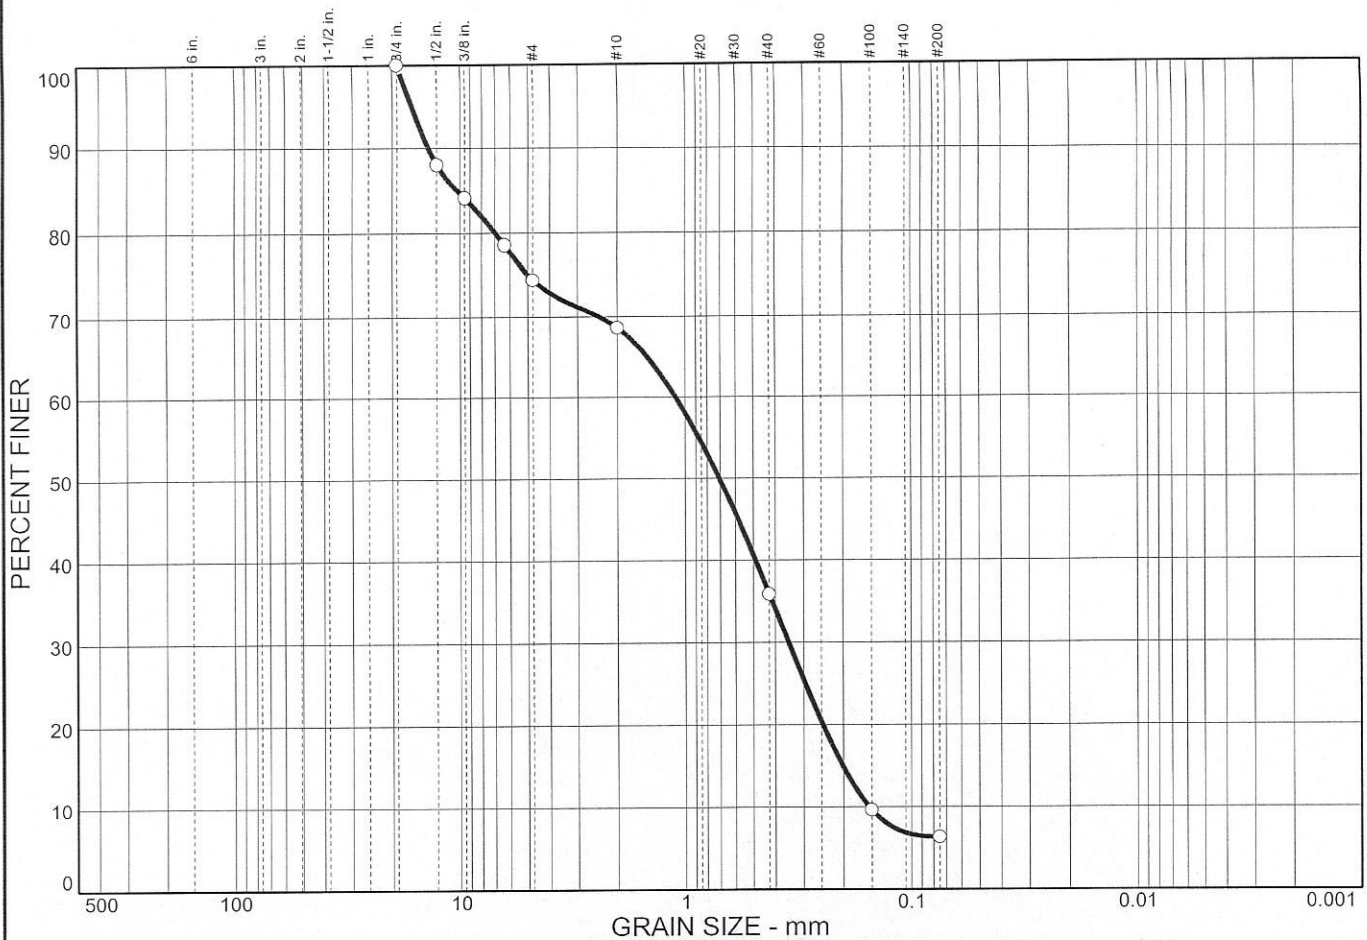
% COBBLES	% GRAVEL	% SAND	% SILT	% CLAY
0.0	25.4	68.3	6.3

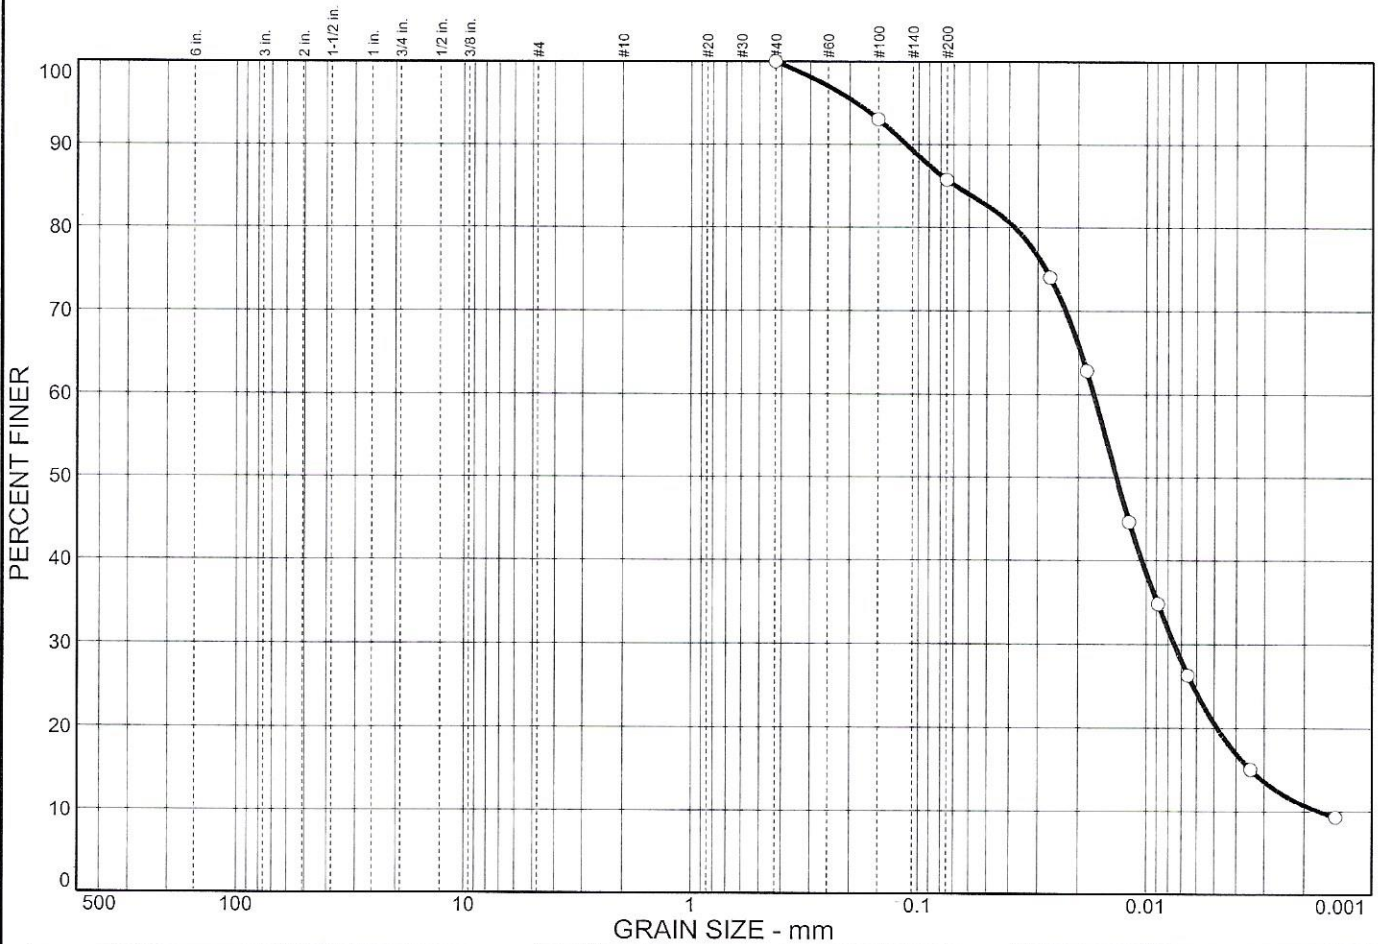
% COBBLES	% GRAVEL	% SAND	% SILT	% CLAY
0.0	0.0	14.3	65.2	20.5

SIEVE SIZE	PERCENT FINER	SPEC.* PERCENT	PASS? (X=NO)
#40	100.0		
#100	93.0		
#200	85.7

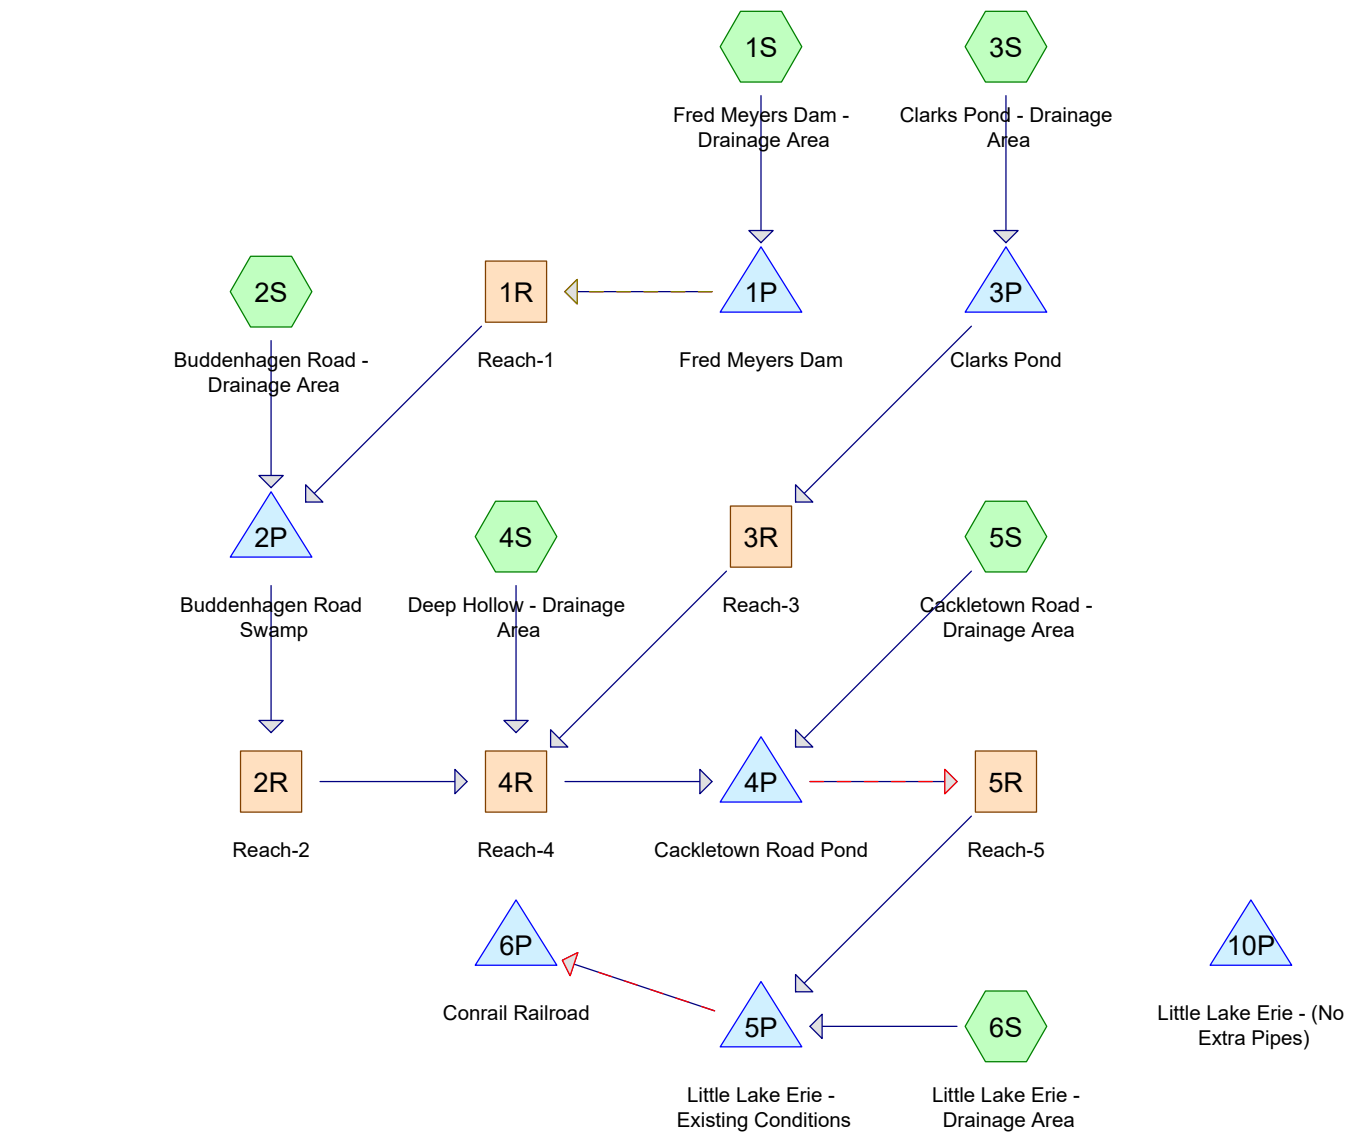
### Routing Diagram for Little Lake Erie - Existing Conditions (03292019)
